January 2024

Subject: Important OPTIMIZER[®] communication to address inappropriate suspension of CCM[®] therapy if a charging error occurs.

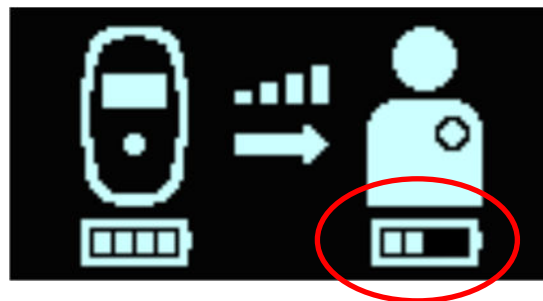
2. Pay particular attention to the implanted device's battery charge indicator, which we have circled in red in the figure.
3. Stop charging when you notice the leftmost 2 bars are solid (as indicated in the figure). There will be a third, adjacent bar blinking.

- Impulse Dynamics recommends all patients with implant card showing model CCM X11, who have experienced one or more charge errors (indicated by the display of “A9” on their charger), charge their implanted device to no more than 75% of full capacity. To accomplish this:
 1. During weekly charging, monitor the charging feedback screen (shown below) displayed on the Vesta/Guardio charger.

Checking the feedback screen every 5 to 10 minutes is sufficient to avoid charging over 75% and potentially triggering another "A9."
